Maine Department of Transportation Coastal Wetland Tidal Restriction Study

May 2004

**US Army Corps
of Engineers**

Planning Assistance to States

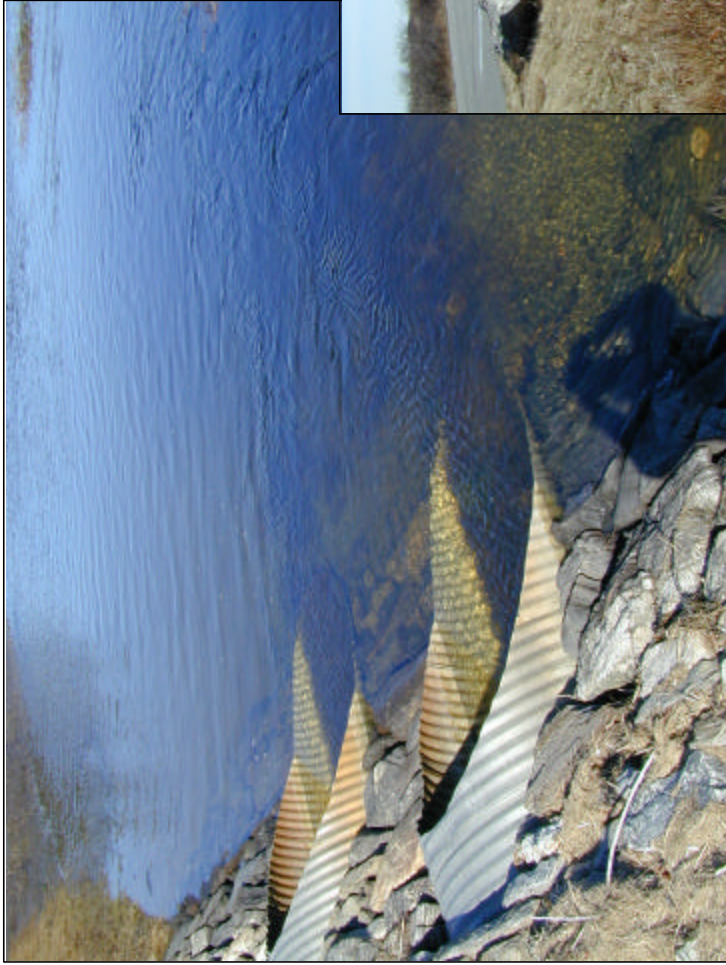
There are two 48-inch diameter corrugated metal pipes running perpendicular to the road. The culverts appear to be in good condition with no problems evident. The culverts were designated as the north culvert and the south culvert. The north culvert had a marsh side invert of 0.77 feet NAVD88 and the south culvert had a marsh side invert of 0.87 feet NAVD88. The north culvert and south culvert had ocean side inverts of 0.85 feet and 0.67 feet, respectively. The culverts were measured to be 56.5 feet long (invert edge to invert edge).

1. The culverts appeared to be in good condition.
2. There does not appear to be any significant tidal restriction due to these culverts.

Site BBH 13 - Ocean side of Culvert at Todd Pt. Road

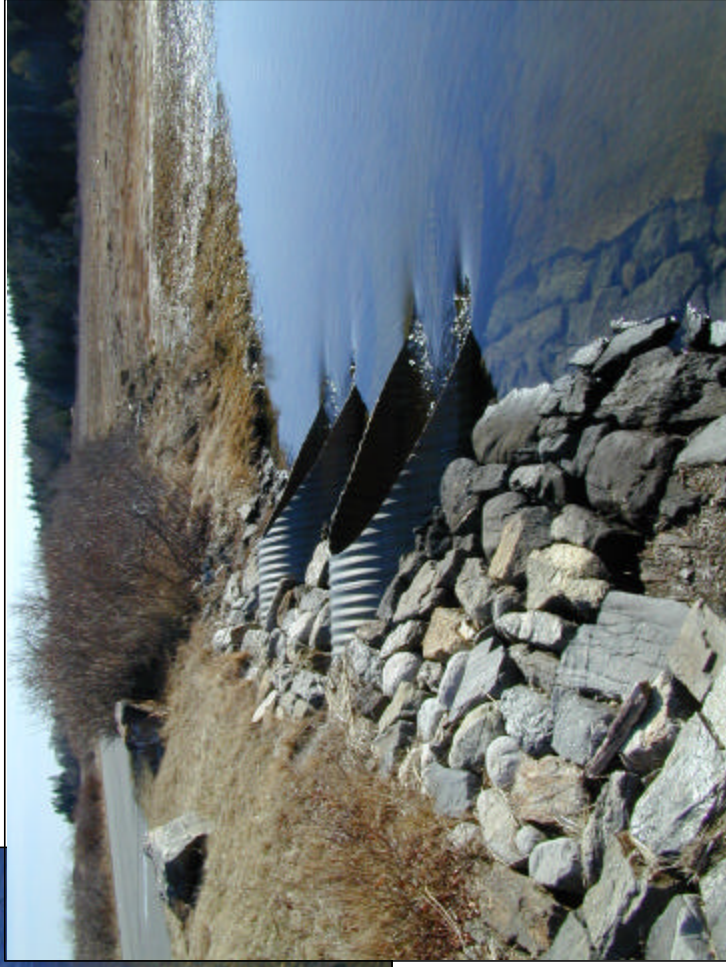
Site BBH 13 - View marsh side of culvert at Todd Pt. Road

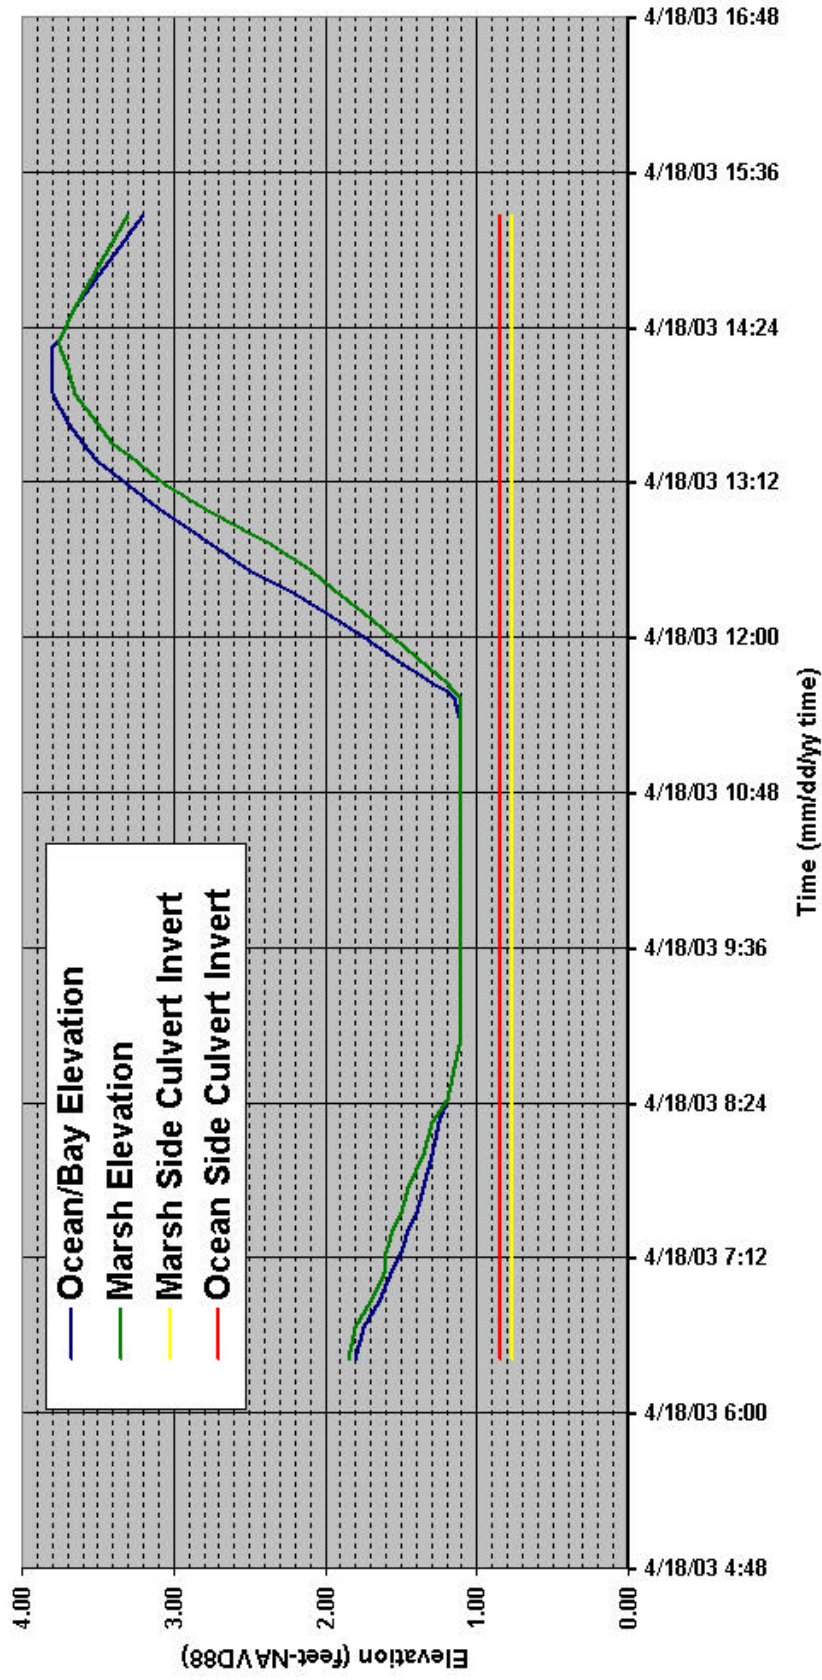
BBH 13 Tide Data Plot

The figure shows that the marsh reaches the same elevation as the ocean side channel with little or no lag in time. It was observed that the marsh and ocean side marsh essentially go dry with only puddles remaining.

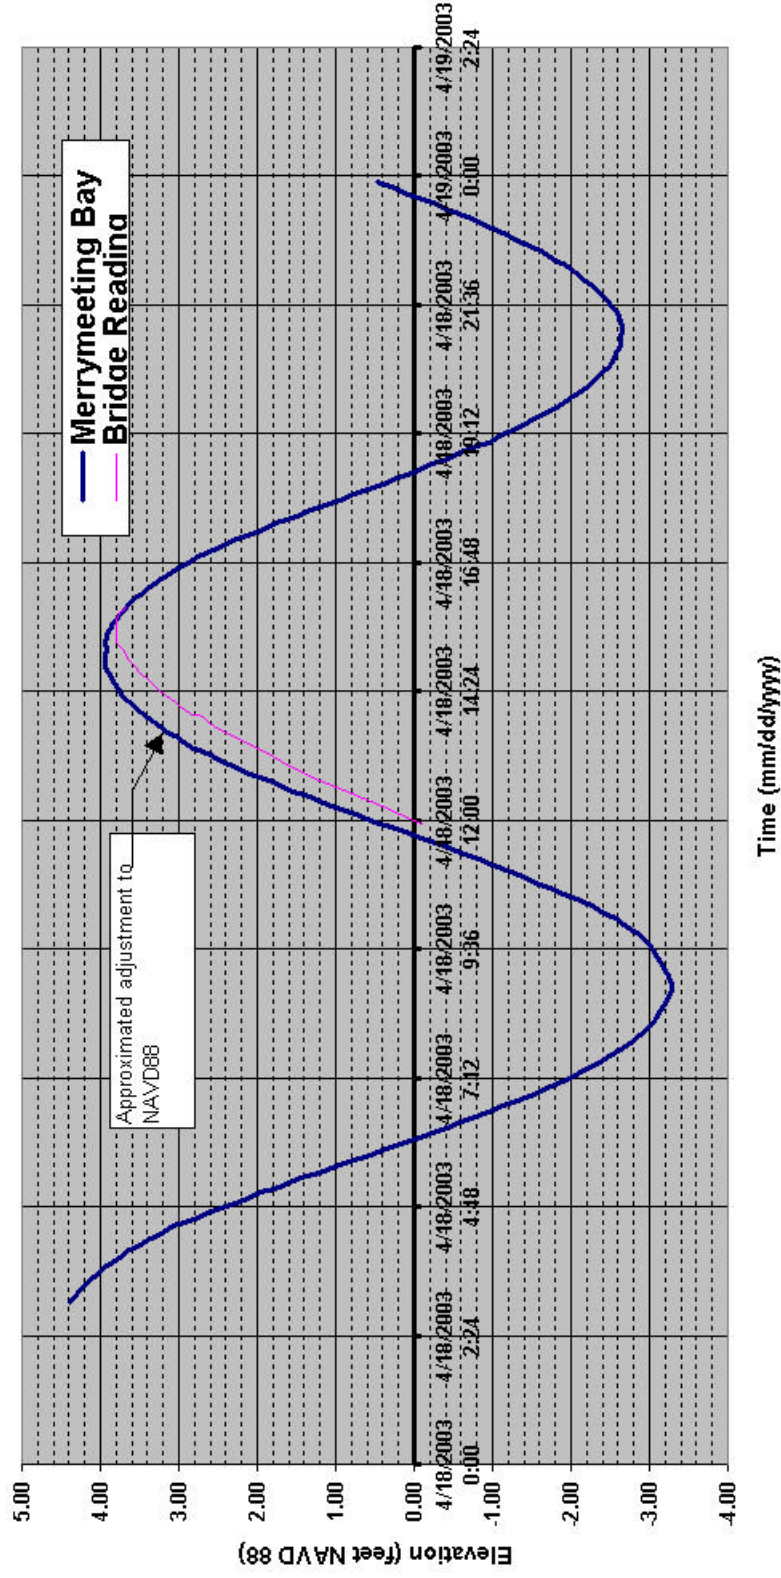
BRK 106 Tide Data Plot

Based upon the elevation data collected there does not appear to be a tidal restriction caused by the bridge at high tide.

Low tide was not observed due to large amounts of marsh debris on the tide board. However, considering the nearly unrestricted opening and the unrestricted high tide elevation it would be expected that no restriction would occur at low tide.

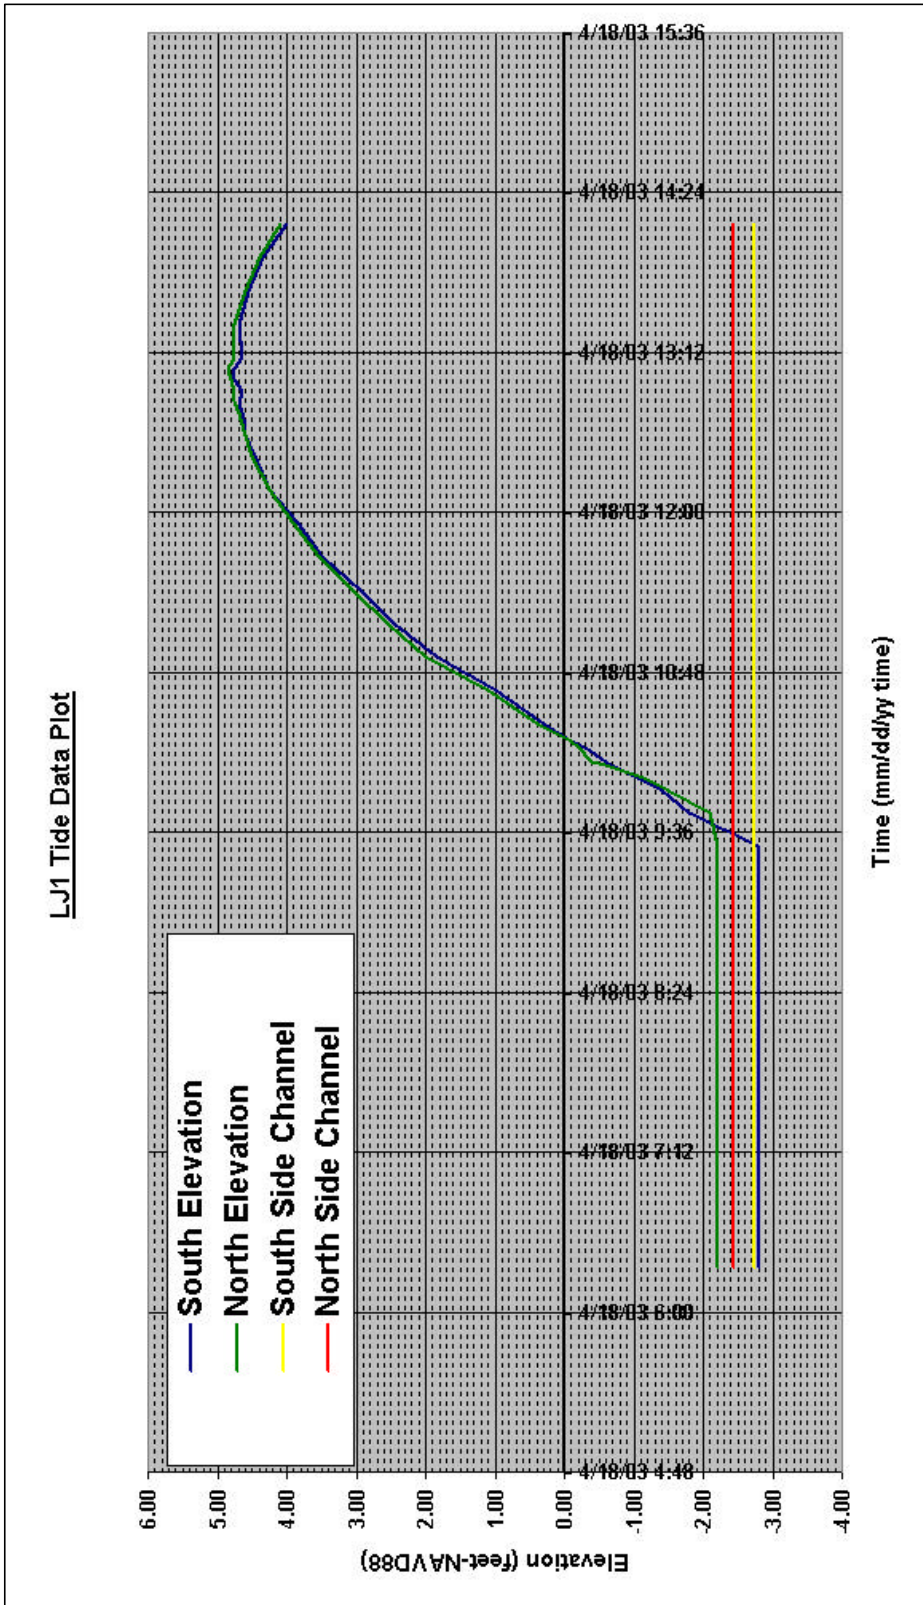
Figure 3 shows that the maximum tide height on the south side was reduced by approximately 0.1 feet when compared to the north with no time lag noticeable. This slight difference may have been caused by wind.

The data collected for the one event monitored show the north and south side of the causeway experienced a similar tide range.

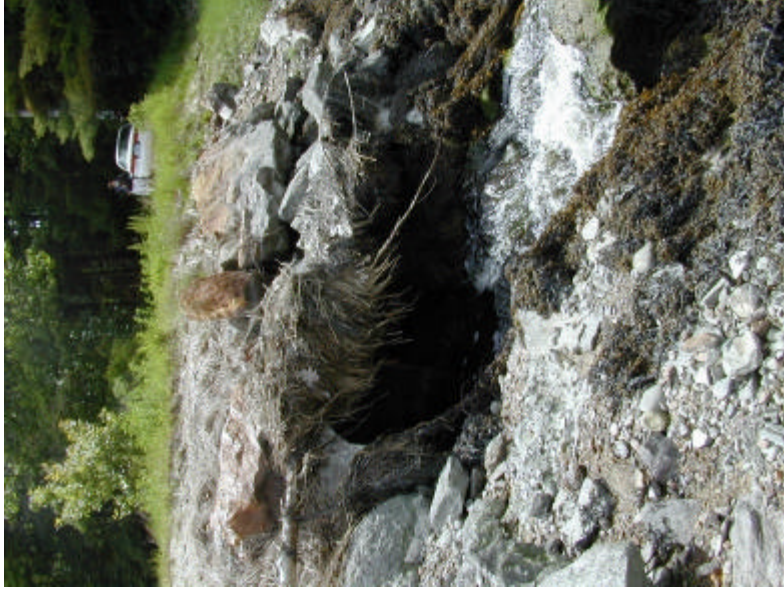
The culvert is a concrete culvert, approximately 25 feet in length with an inside diameter of 3 feet. The marsh side of the culvert has an invert of 1.34' NAVD88. The ocean side of the culvert has an invert of 1.62'. The culvert is in good condition but there is some erosion around the culvert headwall that may be due to over topping during storm tides

Site ORI 03 – Ocean side of culvert under Long Reach Lane.

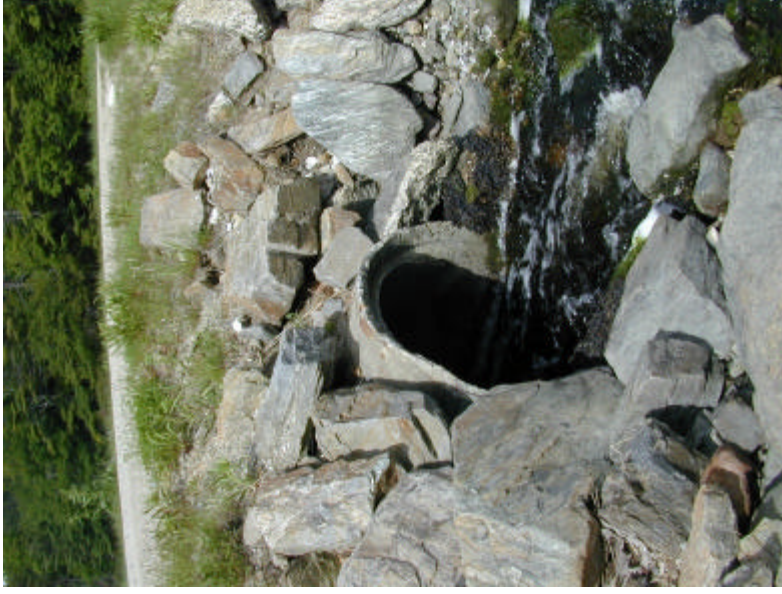
Site ORI 03 – Marsh side of culvert under Long Reach Lane.

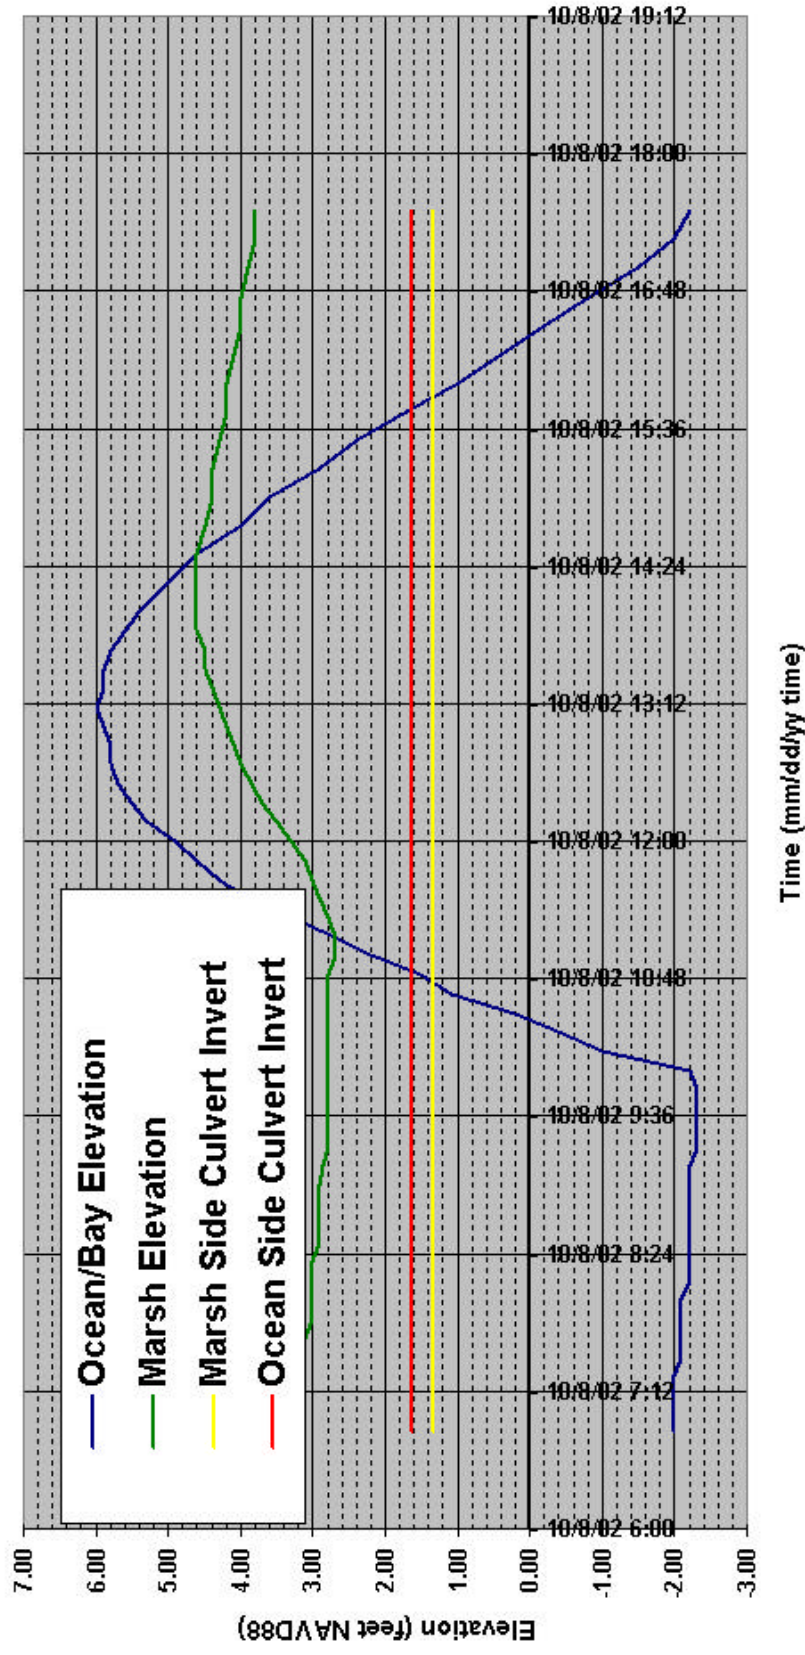
Figure 3 shows that the maximum tide height on the marsh side is reduced by approximately 1.40 feet with a time lag of approximately 40 minutes for this magnitude of tidal event. As the tidal plot shows, the high tide elevation is substantially reduced. This is true for the low tide elevations as well. It is evident that the culvert causes a significant reduction in tidal range.

Looking at the plot the low tide elevation on the ocean side was about 5.0 feet lower than the marsh side. As mentioned the culvert is causing a significant reduction in tidal range in the marsh. The marsh side water surface elevation never makes it close to the culvert invert. The marsh seems to be healthy, but its vertical range has certainly been reduced due to the tide range reduction. Also, high velocities through the culvert were observed. If this culvert were replaced in the future hydraulic modeling could be used to properly size the culvert to increase tide range and reduce the current speeds.

1. Providing a larger opening at the site would increase the tide range in the marsh which may increase the amount of saltmarsh and the overall health of the marsh by providing increased tidal inundation at high tide and drainage at low tide. Computer modeling of the culvert and the marsh would be needed to determine the correct size.

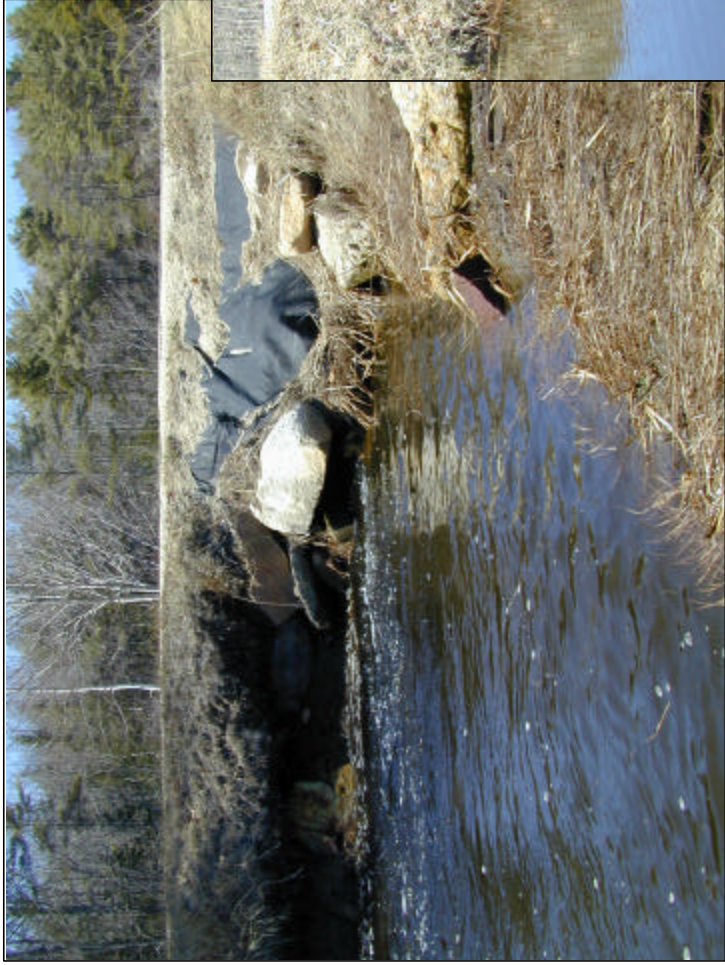
1. The culvert may be in need of some repair. The ocean side banks show noticeable erosion.

Site PHI 01 - Ocean side of Culvert at Route 209

2. Providing a larger opening at the site is not likely to significantly increase the height of the tide in the upstream marsh, but may improve marsh drainage. This would cause a larger tide range in the marsh (all gains would be at low tide). Further investigations including computer modeling of the culvert and the marsh would be needed if it is desired to analyze alternative culvert sizes and inverts for environmental improvements.
3. Drainage might be improved by adding a second culvert at a lower elevation.

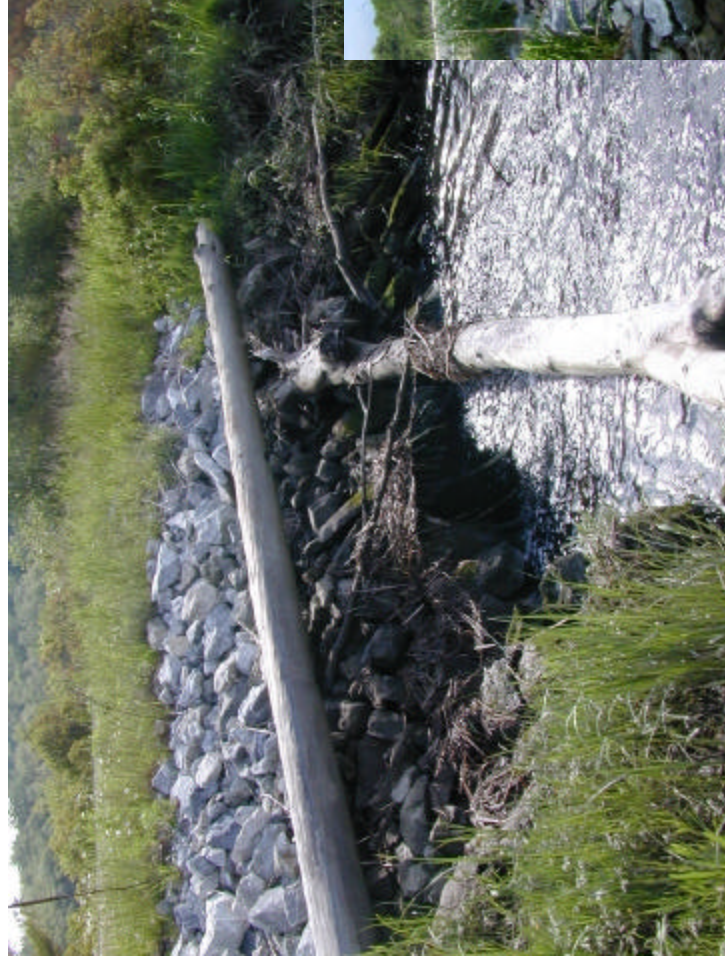
1. The culvert is in good condition with no apparent flow/scour issues evident.
2. The marsh tide was reduced by 25 percent of the ocean side tide range for the event monitored. A larger opening would increase the tide range to some degree, which would increase tidal inundation at high tide. However, due to the low salinities at the site it may be unlikely that salt marsh can be restored. Some investigation of the influence of the Kennebec River on this area would be needed. Further investigation of how salinities vary over the course of the year downstream of the site would be useful in predicting the success of attempts to restore salt marsh to this area.

Site PHI 14 - Ocean side of Route 127 culvert

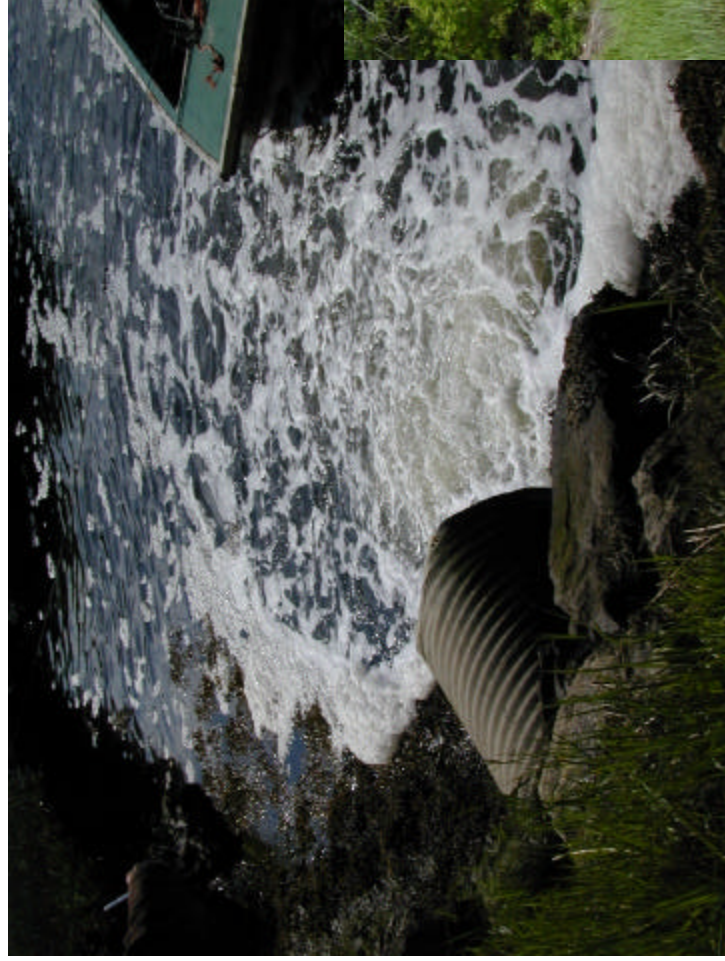
1. The culvert is good condition with some possible scour evident.
2. Providing a larger opening at the site would increase the tide range in the marsh which may increase the amount of marsh and the health of the marsh by providing increased tidal inundation at high tide. Computer modeling of the culvert and the marsh would be needed to determine the correct size.
3. Drainage from the marsh, if desired, could be improved by adding a second culvert at a lower elevation.

Site PHI17A – Ocean side of Indian Rest Road culvert.

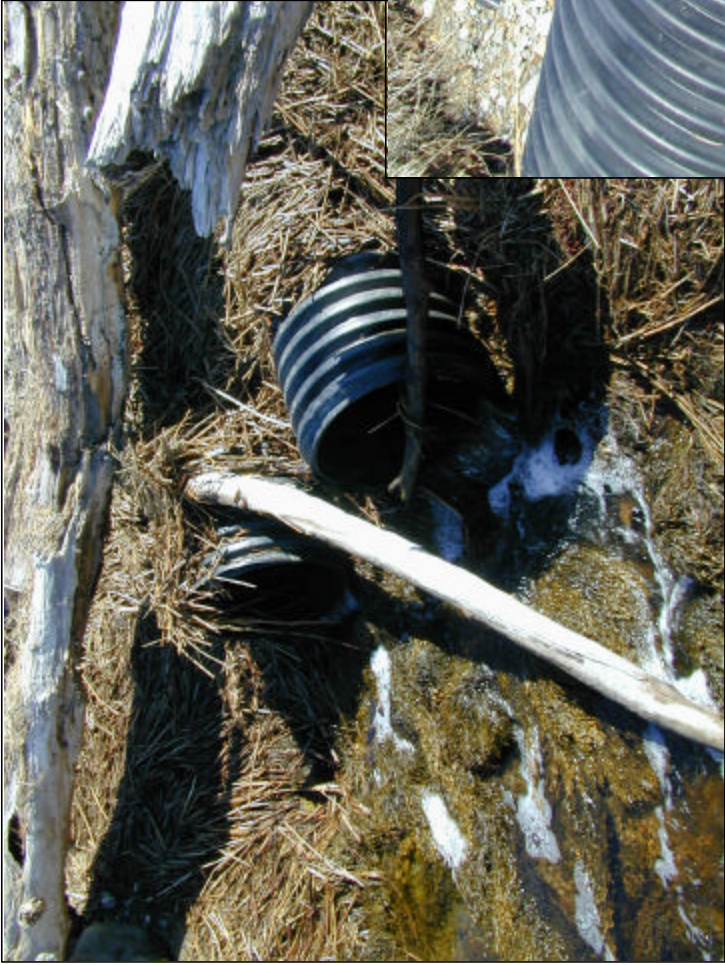
1. The culverts’ condition was good with no problems evident.
2. It does not appear that larger culverts are needed to increase the high tide. The high tide elevations in the marsh match the oceans side elevation for the event monitored. However, drainage appears to be impacted by the vegetation and sediment build-up at the culverts. Clearing this area would improve marsh drainage at low tide. Before this is considered, an ecological evaluation would be needed to compare the benefit of the existing ponded area near the culvert to an alternative inter-tidal area.
3. There was some *Phragmites* observed along the west side of the marsh.

Site PHI 102 - Ocean side of Culvert at Route 209

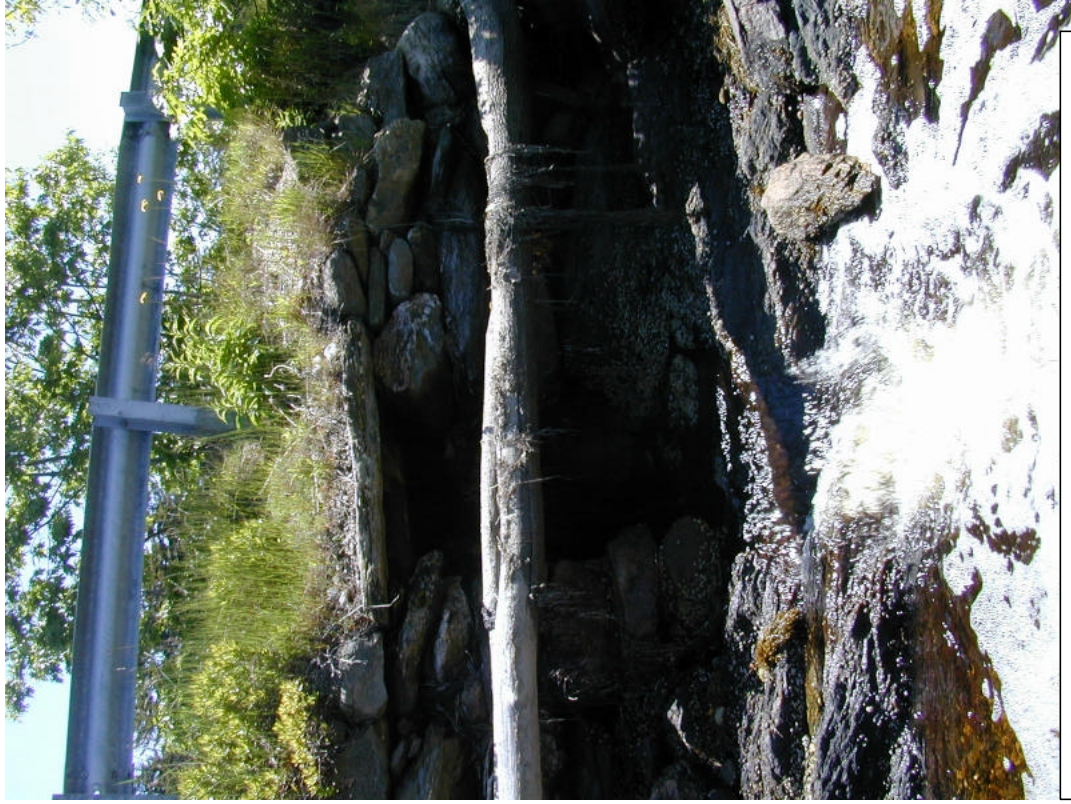
1. The culvert is in poor condition and will likely be replaced by ME DOT in the near future.
2. Providing a larger opening at the site would increase the height of the tide in the upstream marsh and maintain the health of the marsh by providing increased tidal inundation at high tide. Computer modeling of the culvert and the marsh would be needed to determine the correct size.

Site SMP 03 - View ocean side of Culvert at Route 216

3. Complete draining of the upstream marsh at low tide would involve removing the rock bar, lowering the existing channel and culvert invert. Before this is considered, an ecological evaluation would be needed to compare the benefit of the existing impounded area near the culvert to an alternative inter-tidal area.

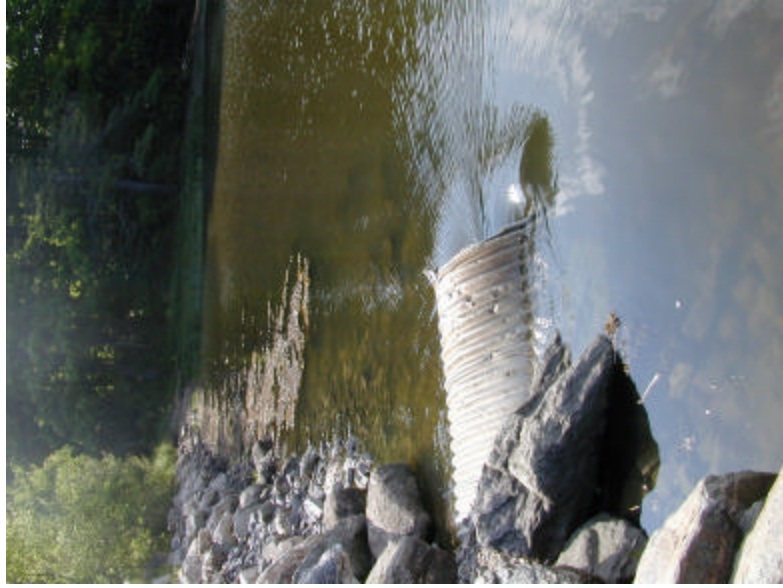
1. The culvert is in good condition with some possible scour evident.
2. Providing a larger opening at the site with a lower culvert invert would increase the tidal inundation at high tide and provide improved drainage at low tide. Before this is considered, an ecological evaluation would be needed to compare the benefit of the existing ponded at low tide to an alternative inter-tidal area.

Site WPT17 – Marsh side of culvert.

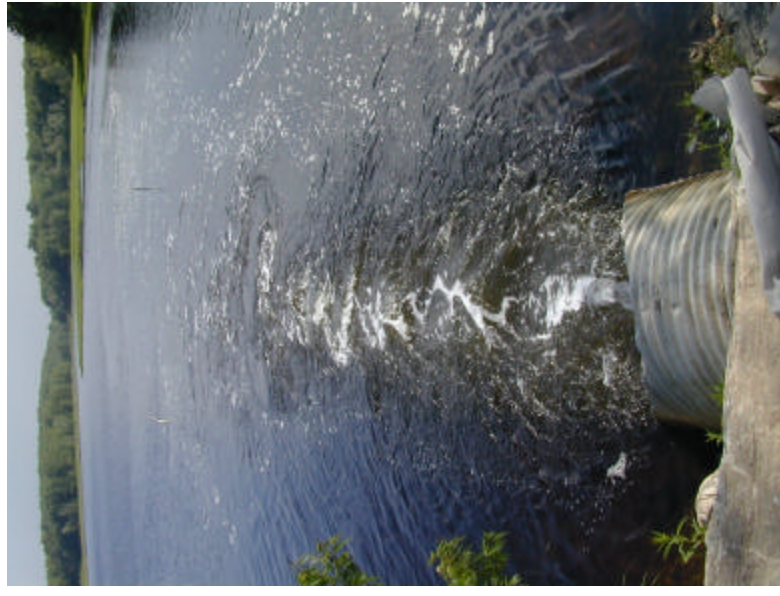
Site WPT17 – Ocean side of the culvert.
